Figure 1: Automotive Steering Component

**Problem:** A manufacturer of automotive steering components needed to verify manufacturing process consistency. A machine vision system was to automatically inspect manufactured parts for process deviation during the manufacturing process. Actual measurements were not as important as the difference in measurement from one inspection to another.

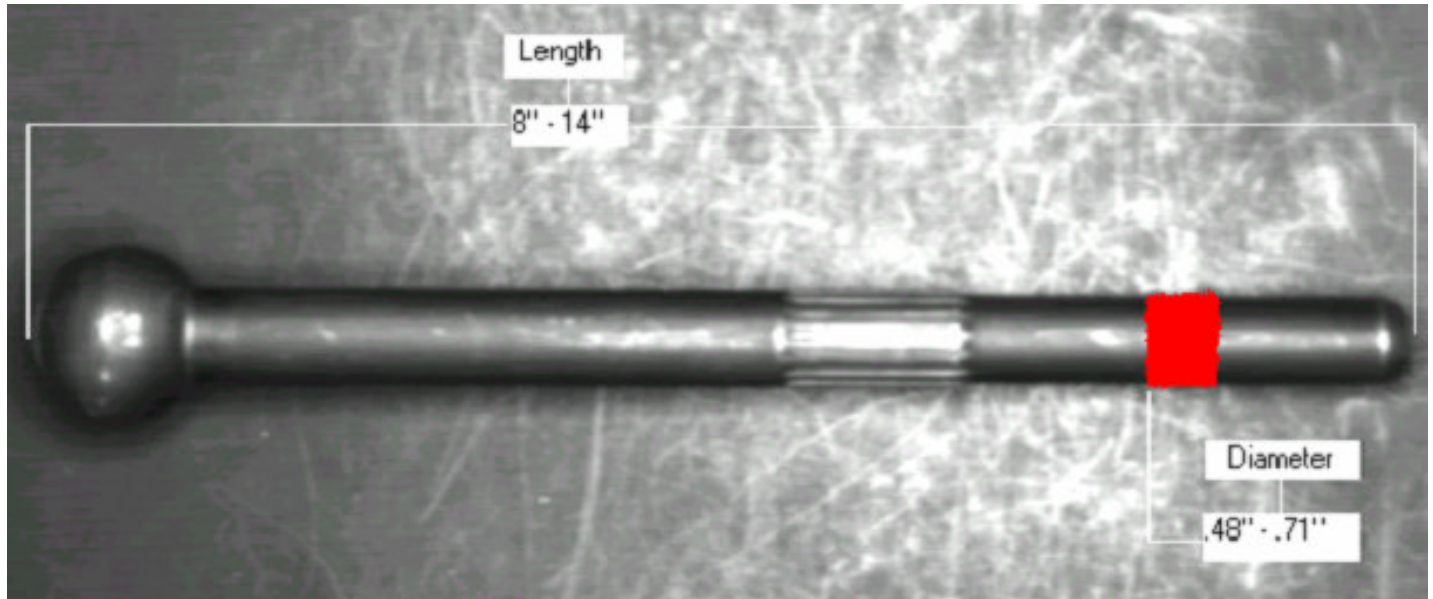
**Solution:** Stand-alone inspection system retrofitted to existing part handling system. Diffuse fluorescent illumination lighting the part from the bottom. FOV approximately 15" to accommodate all part sizes. Part number of the inspected part is selected from a Windows recipe menu. Parts are indexed in place by the existing part handling system. A Part In Place signal triggers the camera to acquire a series of images. Software tools measure the overall length of the part, the arc at the ball and the diameter of the rod. These measurements are not stored, but

rather are simply used for comparison from measurement to measurement to verify that the measurements remain within an acceptable range.
